Machine Gun Liner Bond Strength

ARL-CR-595

August 2007

14. ABSTRACT Bond strengths of two Stellite 21 liners in the M2 0.50-cal. machine gun have been measured. Both liners were obtained from machine-gun barrels that had been retired from service. Liner bond strength from one of the barrels was measured to be ~750 psi. The other liner fell out of the barrel during sectioning, and its bond strength was much lower. Simple calculations showed that a bond strength of 750 psi was compatible with a shrink-fit process. In this case, the bond strength was shown to be sufficient to resist the forces on the lands and grooves of the liner due to spin-up forces on the bullet.

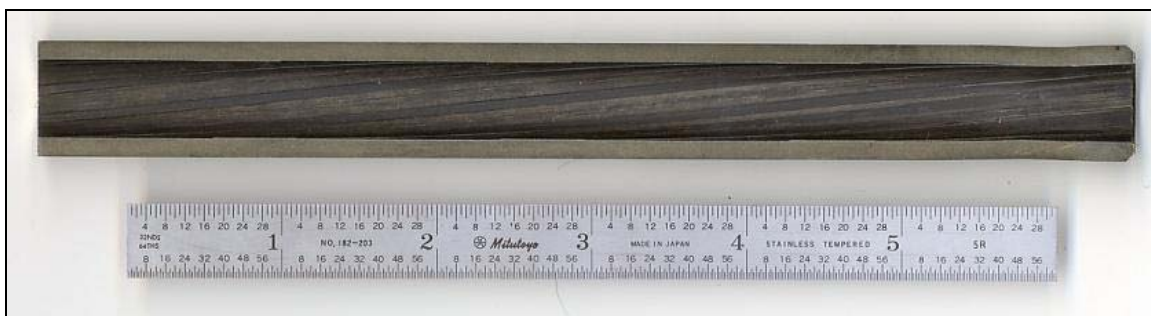
Figure 4. Stellite 21 liner removed from the first M2 machine gun barrel.

Figure 3 shows the interior surface of the breech end of the first machine gun. The sectioning reveals that the liner is slipped into the gun tube and held in place by a steel end plug. When the part containing the 7-in length of liner was sectioned, the liner fell out. A picture of the sectioned liner from this tube is shown in figure 4.

Gun-powder residue was found on the outer surface of the liner. A visual inspection of the lands and grooves showed little or no evidence of any wear. However, at about 1/2 in from the end of the liner (the right end of the liner shown in figure 4) is a small crimp in the liner. It is surmised that propellant gasses got between the liner and gun tube and partially crimped the liner. This failure in the liner may have been the reason for the removal of the gun from service. It was found that the lands and grooves of the liner lined up perfectly with those in the gun tube, indicating that there had been no rotation of the liner inside the gun tube before the tube was sectioned.

This limited investigation does not constitute a complete analysis of liner failures in the M2 machine gun. The fact that two different liner-failure modes were seen in the two barrels that were examined is serendipitous. The first barrel liner examined failed most likely due to propellant gas that got between the liner and barrel, crimping the liner and disturbing the passage of the bullet. This failure apparently occurred after very few rounds were fired, as indicated by the low wear on the liner. This type of failure might have been caused by a manufacturing defect and should occur much less often than the second type of failure observed. The liner in the second barrel that was examined failed by the normal erosion process associated with the interior ballistics cycle as evidenced by the numerous pits and cracks.
